# ***Resolution Manual For Metal Building Construction Job Site Imperfections***

## INTRODUCTION

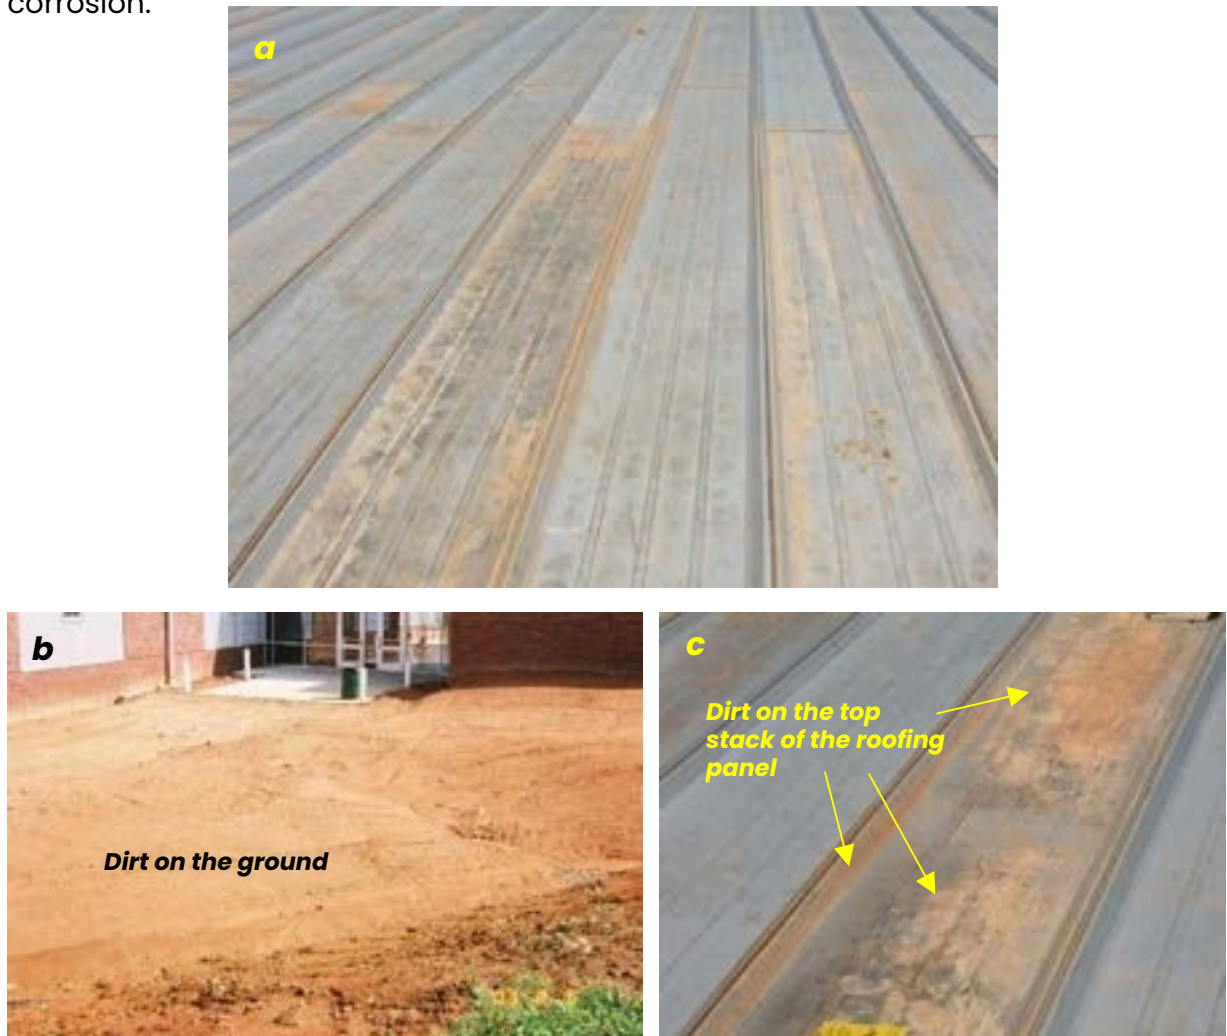
Staining and an inconsistent appearance of bare GALVALUME<sup>®</sup> Coated Sheet Steel roofs can be caused by dirt being introduced by either foot traffic and/or poor storage practices. The example in Figure 1 showed that the dirt on the roof (Figure 1a) matched the dirt on the ground (Figures 1b). The dirt was concentrated on the roofing panels on the top of the stack (Figure 1c) and transferred to the other panels by construction workers walking on the roof. If the dirt is not cleaned immediately after installation, it will cause staining and an inconsistent appearance to the roof, and possibly cause premature corrosion by trapping the moisture on the roof. Therefore, dirt and other debris should be cleaned immediately after installation.

Figure 1. Photographs of stains and inconsistent appearance of a bare GALVALUME<sup>®</sup> roof (a), dirt on the ground at a building site (b), and dirt concentrated on the roofing panels on the top of the stack (c).

The best way to avoid staining of panels is to maintain proper storage and handling practices during the entire construction process to avoid dirt getting on the panels in the first place. Annual washing of the building is recommended to maintain the overall appearance of the building. The useful life of the roof will also be extended by removing dirt and other moisture trapping debris, which can cause premature corrosion.

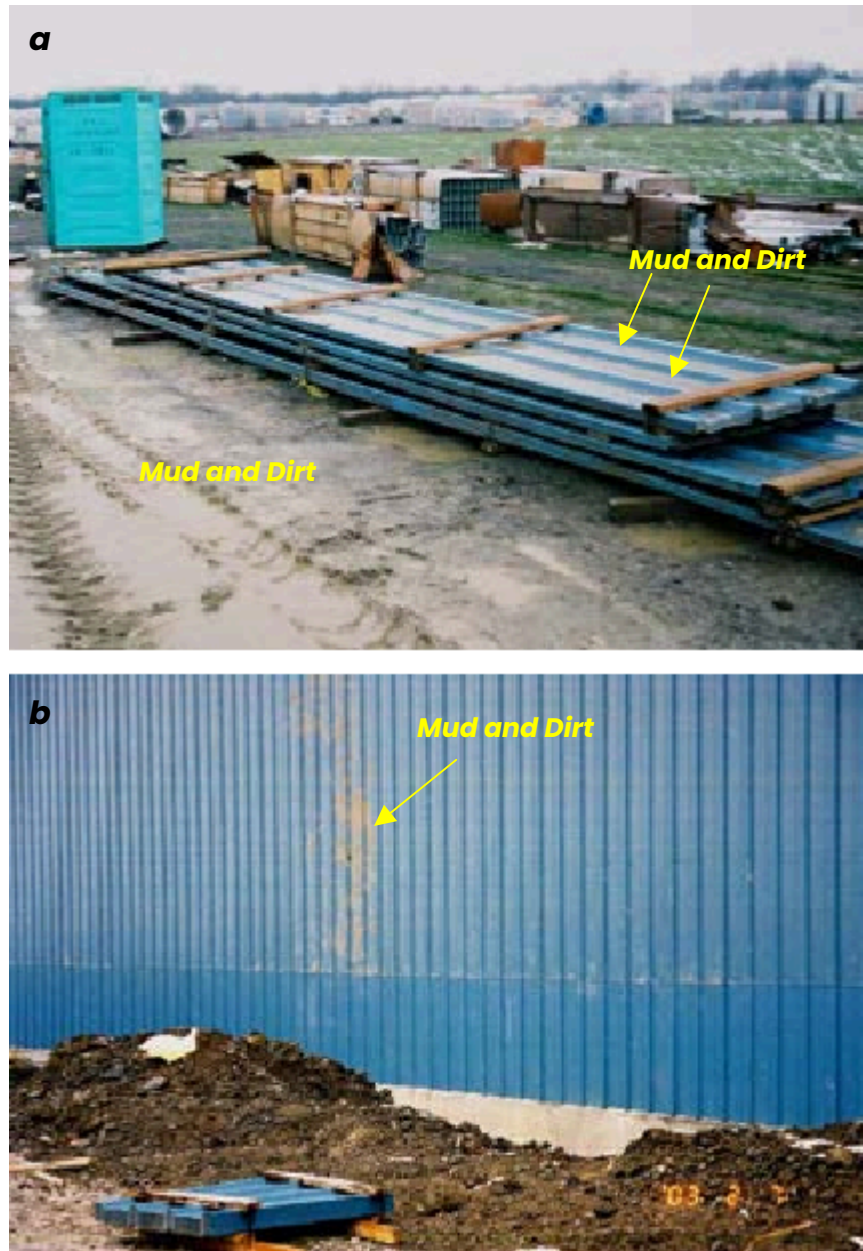
Similar dirt issues can also occur on prepainted panels. Figure 2 shows dirt and mud on the job site was transferred onto the surface of the prepainted GALVALUME® sidings before installation (Figure 2a), and the mud remained on the panels after installation causing appearance issues (Figure 2b). Dirt also concentrated on the top panel of the stack. The best way to avoid this situation is to maintain proper storage and handling practices during the entire construction process to avoid the dirt and mud getting on the panels in the first place. Dirt and mud should be cleaned immediately after installation.

Figure 2. Photographs of mud and dirt on the prepainted GALVALUME® siding panels (a) before and (b) after the installation.

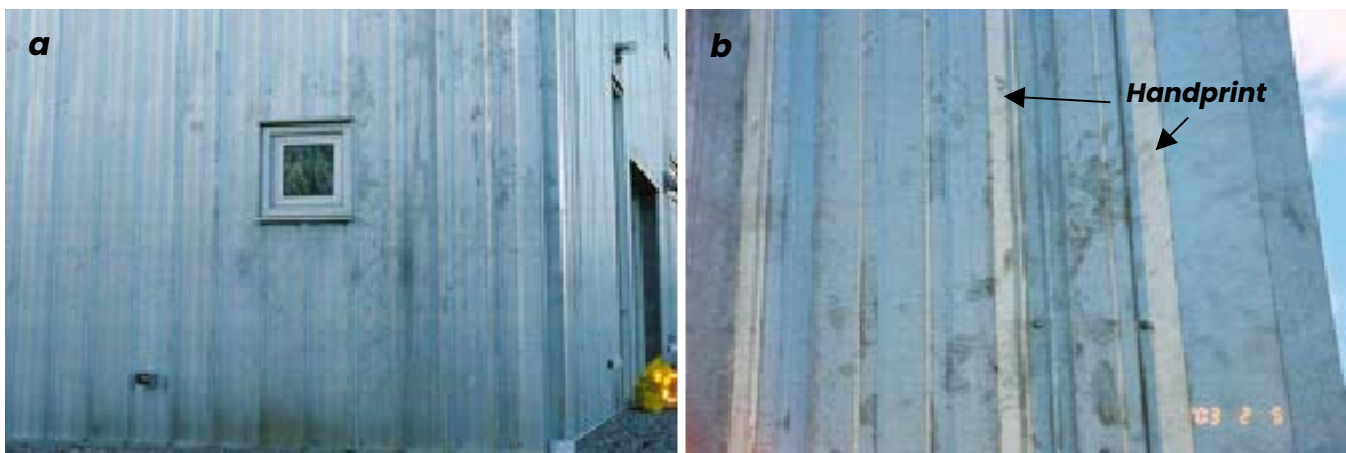
Hand and palm prints on bare galvanized and GALVALUME® panels are the likely result of not using clean gloves in handling the panels during installation. Dirt, oil and perspiration have been shown to be detrimental to the appearance of bare coated products, such as galvanized and GALVALUME® Coated Sheet Steels. Figure 3 demonstrates the results of poor handling practice during the installation of bare GALVALUME® siding, which left handprints on the siding. Figure 4 shows the non-uniform darkening smudge marks due to excessive abrading of the surface of the roofing panels and footprints on the GALVALUME® roofing panels. Panel-to-panel contact, walking on the panels, and not using clean gloves can also cause poor appearance. The contractor should be cautioned, prior to installation, to avoid poor handling practices, since the contractor is ultimately responsible for these imperfections. However, it should be noted that the darkening or smudging does not affect the corrosion performance of the panels.

Figure 3. Photographs of handprints and smudge marks on bare GALVALUME® siding (a), and close-up view (b).

Instead of bare GALVALUME® Coated Sheet Steel, ACRYLUME®<sup>2</sup> Coated Sheet Steel can be used, which provides better hand, footprint and smudge mark resistance. ACRYLUME® Coated Sheet Steel has a very thin clear acrylic coating over GALVALUME® Coated Sheet Steel. The acrylic coating also provides better protection during storage.

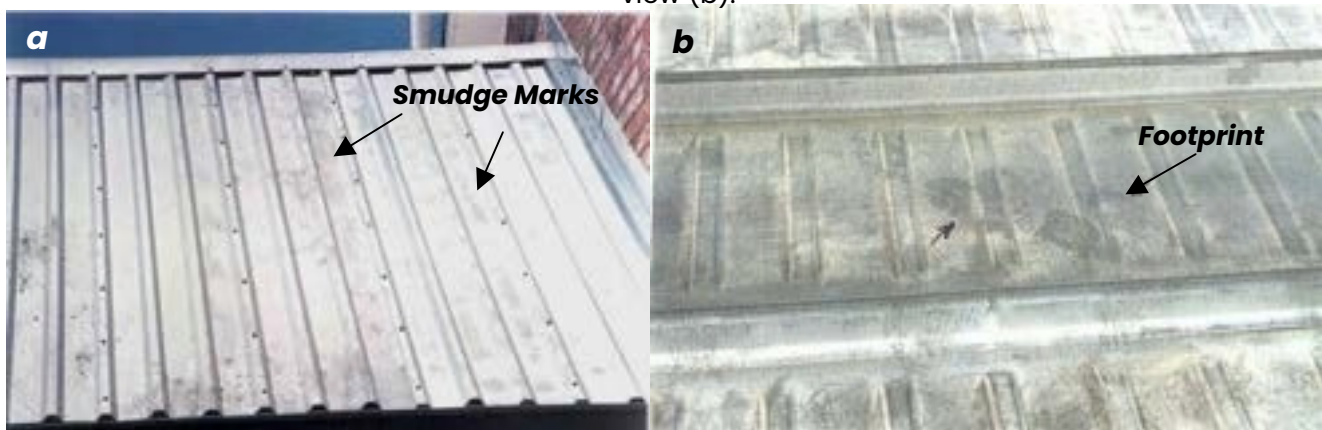
Figure 4. Photographs of smudge marks (a) and footprints (b) on bare GALVALUME® roofs.

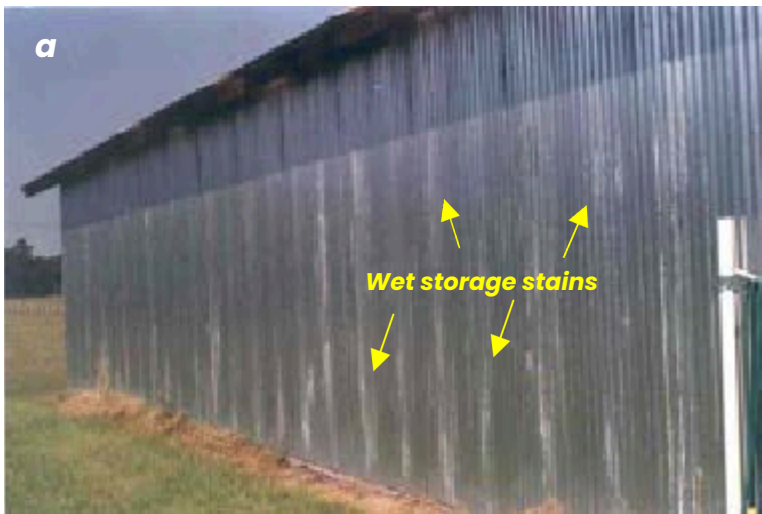
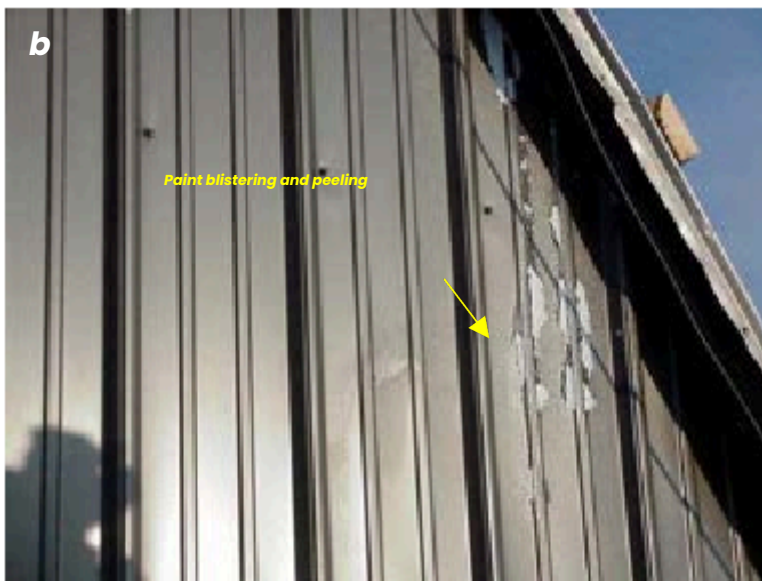
Wet storage stains are white or black corrosion products formed while the hot dip galvanized or GALVALUME® Coated Sheet Steel is stored in coil form or in a tight stack. One of the most common sources of storage stain occurs when the steel is held in a tight bundle of panels. When steel is exposed to moisture and deprived of oxygen, storage stain can occur. Storage stain should be prevented because it is very difficult to remove without affecting the appearance and/or the performance of the product after it has occurred. To prevent storage stain from occurring in a bundle of stacked panels, one can store under roof until use, allow air circulation around the bundle, slope and cover the bundle, and re-cover partially used bundles. More information on storage stains can be found in Butler Metal Building web site at <https://butlermetalbuildings.com/>

Figure 5. Photographs of wet storage stains on bare galvanized steel siding (a), and wet storage causing paint blistering and peeling on prepainted galvanized steel siding (b).

Figure 5a shows white rust and storage stain, on the bare galvanized steel. Wet storage problems are not limited to bare materials. Prepainted products are also susceptible to wet storage issues, which occur when the panels are in bundle form and exposed to moisture, such as the siding panels shown in Figure 5b. The difference with painted panels is that the corrosion starts underneath the painted surface and first appears in the form of blisters or a rough surface, which eventually progress to the point at which the paint peels from the galvanized steel panels. For more information, see National Coil Coater's Association Technical Bulletins at <http://www.coilcoating.org>. Wet storage stain can be easily identified. Typically, there is no orientation to the staining pattern, but the white rust or the stain patterns should be on both sides of the panel. If the panels are still stacked in the bundle, the pattern should be in a mirror image on the bottom side of the panel to the topside of another panel that it was in contact with.

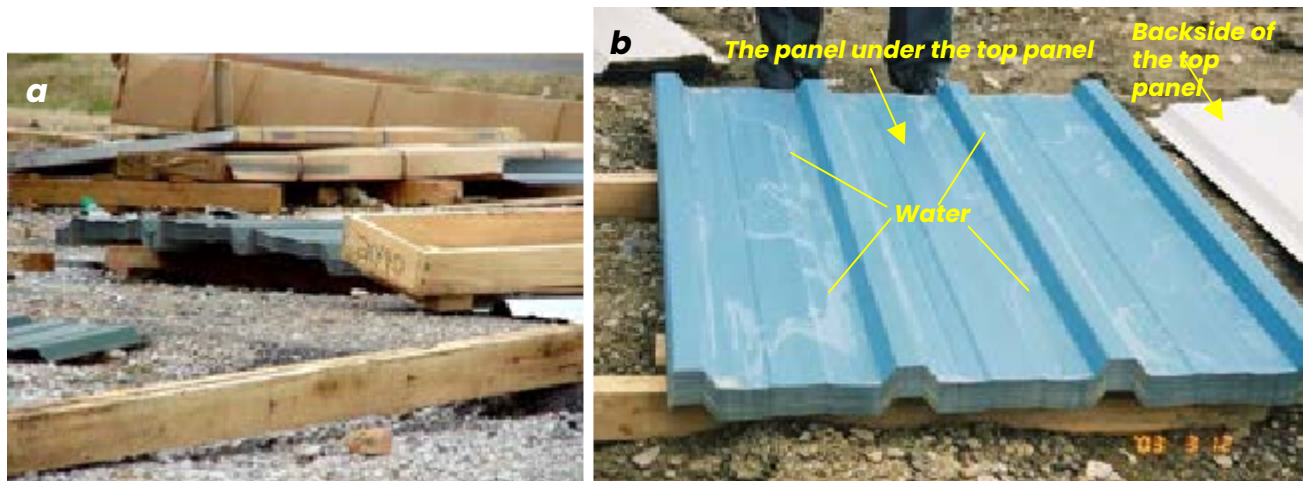
Wet storage conditions are frequently found on job sites where panel bundles are improperly stacked (Figure 6a), or are laid flat on the ground, without protection (Figure 6b). Water can penetrate between the panels by condensation, or capillary action, creating wet storage conditions, which cause paint blistering and substrate corrosion on the prepainted panels, while causing storage stain on the bare hot dip galvanized or GALVALUME® Coated Sheet Steel. Therefore, panels and accessories should not be stored in wet conditions. Care should also be taken to avoid handling damage on the job site. The panel storage condition shown in Figure 6a could potentially create a wet storage condition and cause premature corrosion. It could also cause damage to the panel before installation.

Figure 6. Photographs of panel bundles improperly stacked at the job site (a), and water on the surface of a panel that was in the bundle under the top panel (b).

Bundles should be positioned with one end slightly elevated to permit runoff of moisture from the top of the bundle or from between nested panels. Water-resistant paper will not necessarily provide long-term resistance to moisture penetration from puddled water on top of the bundle. A waterproof cover should be placed over the bundles while allowing for air circulation under the cover (see Figure 7). More information can be found <https://butlermetalbuildings.com/>

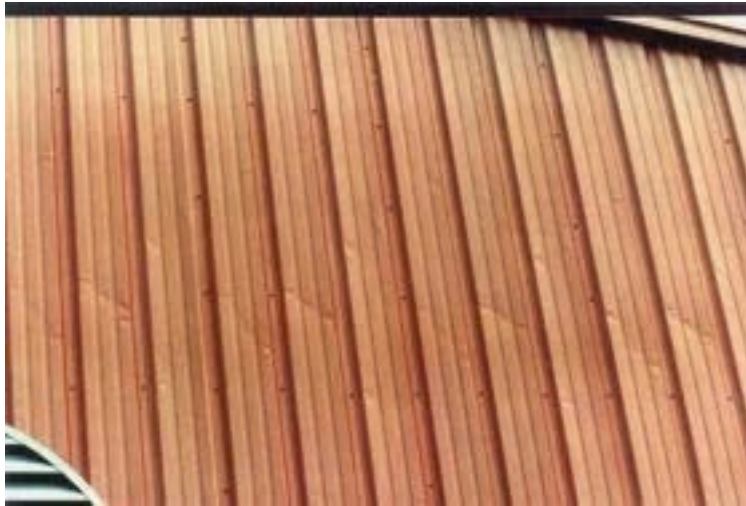
Figure 8 is an example of transit and handling damage. The pattern of the damage is typical of handling issues while panels are still in bundle form. Regardless of whether the damage was caused by blocking, forklifting or by some other external force, it usually exhibits a repetitive pattern. Nevertheless, the damaged panels should have never been installed. Figure 9 shows other examples. Mishandling of the panels caused paint abrasion damage at the radii of the major ribs in the up-down direction (Figure 9a), which could result in premature corrosion. The scratches on the surface of painted panel caused premature corrosion in the damaged area (Figure 9b).

Figure 8. Photograph of damaged panels on the building's sidewall.

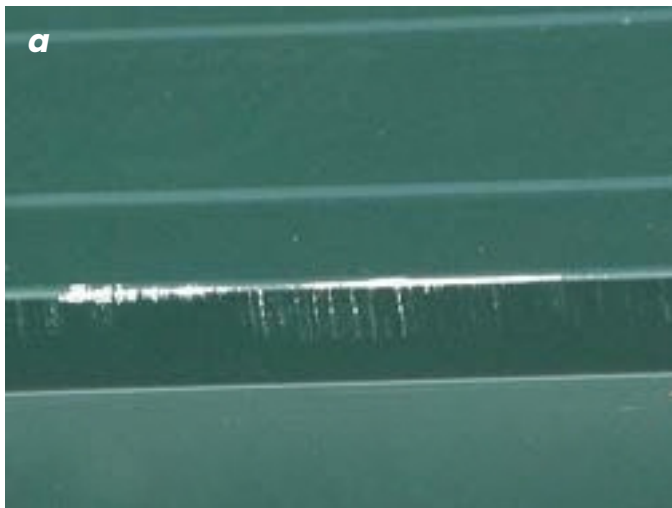
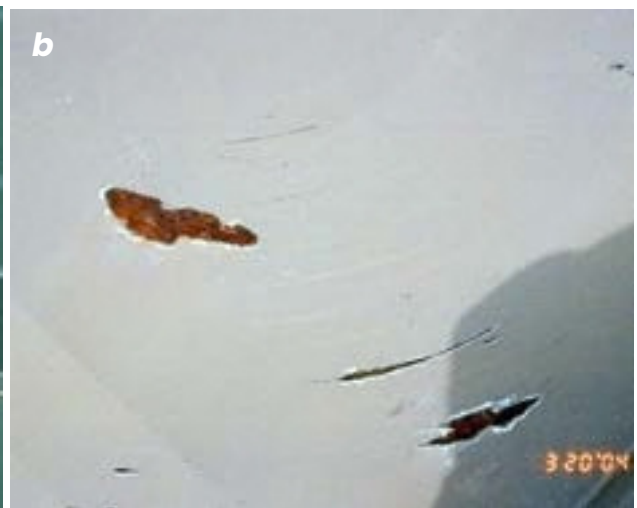
Figure 9. Photographs of paint abrasion damage on the major rib of the panel (a), and scratches on the surface of a painted panel resulted in premature corrosion (b).

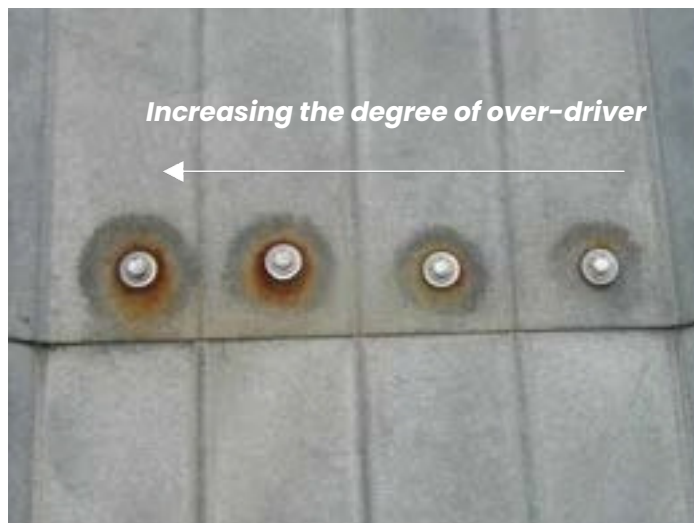
Figure 11. Photograph of the over-driven fasteners. The corroded area around the fastener increased with increasing depth of depression.

Fasteners should be installed properly to avoid being over-driven, under-driven or driven at an angle. Figure 10<sup>3</sup> is a schematic example of the proper and improper installation of fasteners. Properly seated and installed fasteners should be watertight and not allow water to leak or allow water to collect around them. Over-driven fasteners may cause depressions around the fasteners, which can collect water and accelerate corrosion. Therefore, impact-type tools should not be used. Figure 11 is an example of over-driven fasteners. The GALVALUME® material around the fasteners was corroded due to water ponding in the depression. The corroded area around the fastener increased with increasing the depth of the depression. Under-driven fasteners or fasteners that “back out” over time can allow water to leak at fasteners allowing water to saturate insulation causing inside-out corrosion (Figure 12<sup>4</sup>). Driving tools with depth-sensing nose-pieces and suitable speeds can help to avoid these problems.

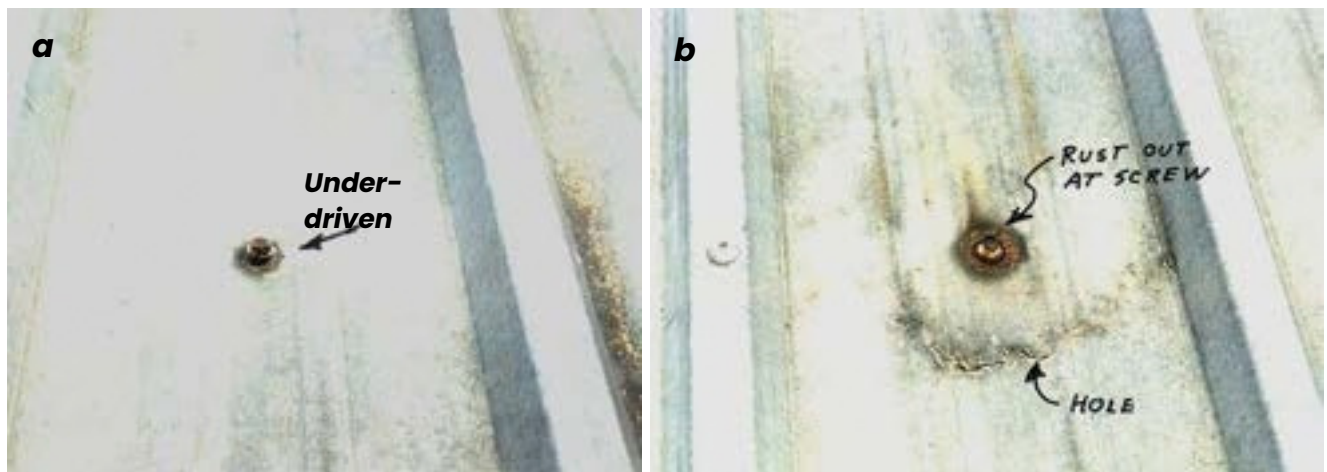
Figure 12. Photographs of under-driven fasteners with water leaking at fastener to cause corrosion at the fastener (a and b), and caused inside-out corrosion due to water saturation of the insulation (b).

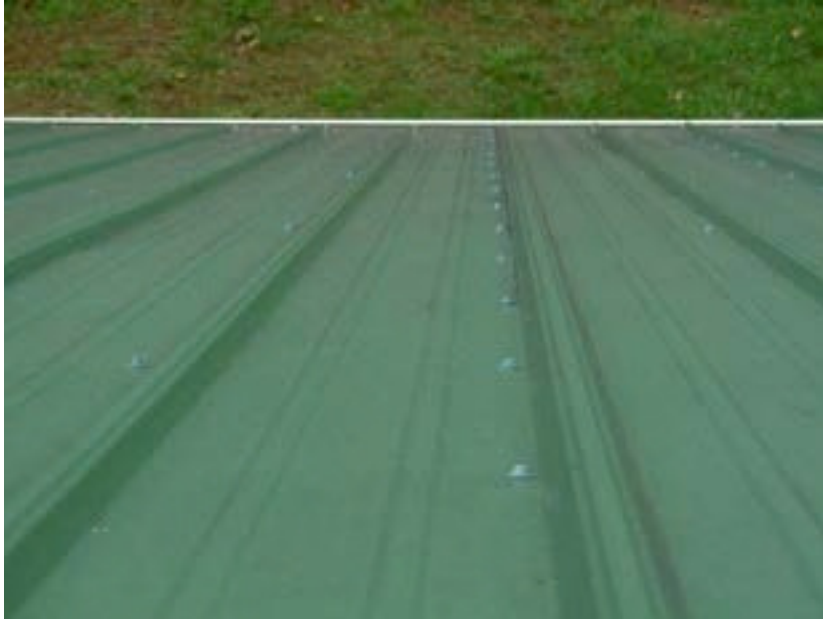
One of the distinctive features of a high slope metal roof is its unique appearance. The choice of the fasteners should match the color and the performance of the roofing panels. Otherwise, the appearance or even the performance of the roof may be adversely affected. Figure 13 shows a green colored prepainted galvanized steel roof with discoloration of the screws. Improper fasteners were used, which resulted in the red rusting of the screws and the discolored appearance of the roof. This problem would not have occurred, if the correct fasteners had been used (Figure 14).

Figure 13. Photograph of the prepainted galvanized steel roof with non-matching screws.

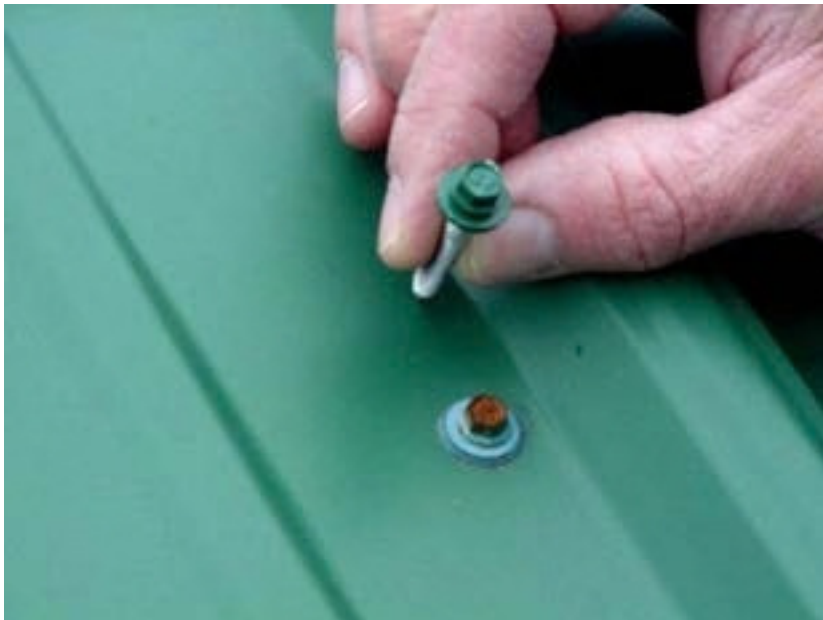
Figure 14. A close view of a non-matching screw with red rust and the correct screw, held in the hand, which should have been used for this application.

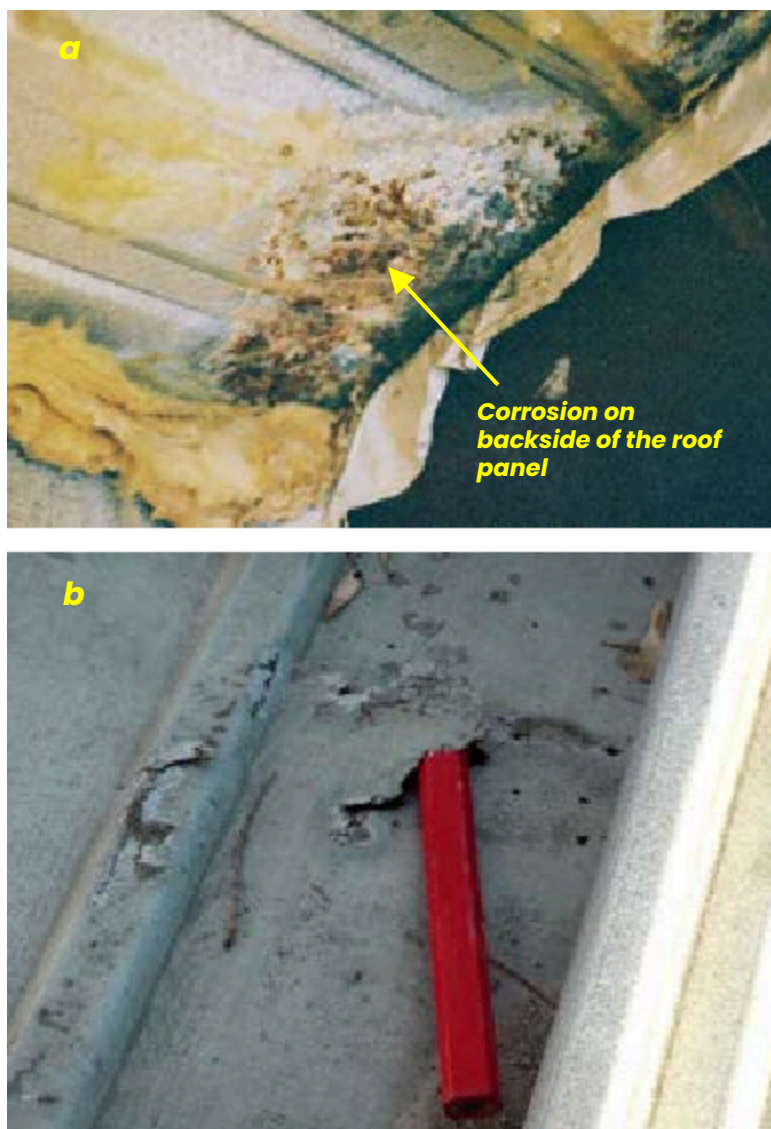
Insulation provides resistance to heat transfer and protects against condensation forming on cold surfaces inside the building or within the wall/roof system cavities. The insulation should have a vapor retarder face on the “warm” side of the insulation. For most buildings, the vapor retarder is on the inside surfaces facing the building interior. The thickness of the insulation must be designed to maintain the temperature of the vapor retarder above the interior dew point under the worst expected outside temperatures. All perimeter conditions and seams must be adequately sealed to avoid moisture penetration of the vapor barrier and provide a continuous membrane to resist the passage of water vapor. Failure to do so could cause wet insulation, which could cause corrosion on the underside of the roof panels (Figure 15a). This corrosion may lead to perforation corrosion from the inside of the roof panels (Figure 15b).

Figure 15. Photographs of roof panel corrosion due to wet insulation. The corrosion of the GALVALUME® panels was observed on the bottom side of the panels after the insulation was removed (a). Perforation corrosion was observed on the topside of the roof panels (b).

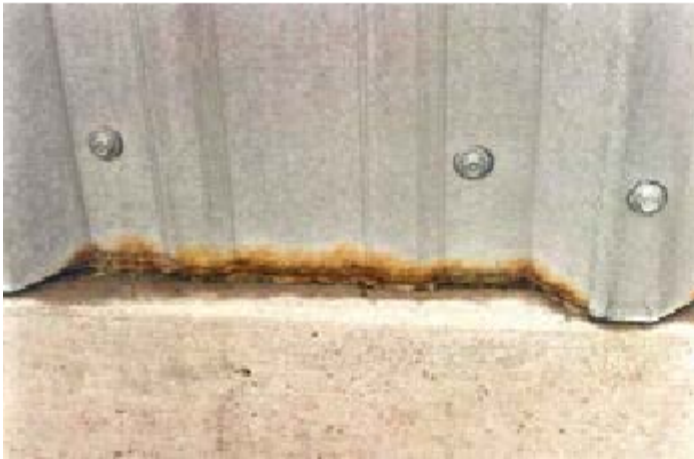
Figure 16 is a classic example of “insulation wicking” causing premature failure of the coated panel. The insulation soaked up the available moisture creating an environment that was always wet causing accelerated corrosion. The contractor should be fully aware that insulation and other building materials that can soak up moisture should not be exposed to the exterior of the building. One solution is to install the insulation at least one inch above the bottom edge of the panels and to fold the insulation face around the bottom edge of the fiberglass (see Figure 17).

Figure 16. Premature corrosion at the bottom edges of the GALVALUME® panel caused by insulation wicking.

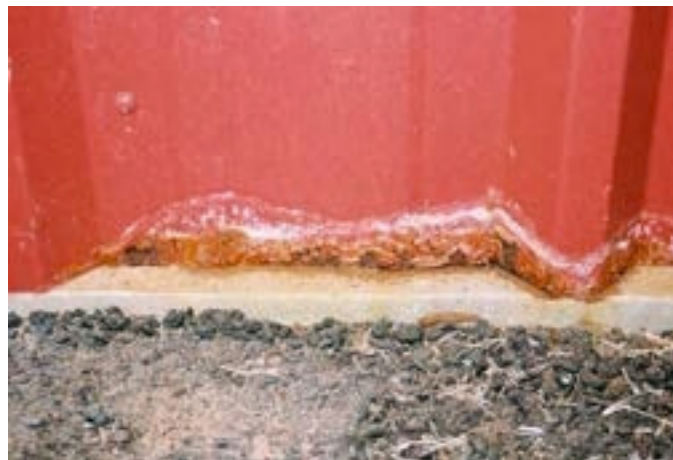
For bare and painted GALVALUME® products, direct contact with cement foundations is not recommended. Accelerated corrosion can occur due to the lime contained in the cement. An example of which with prepainted GALVALUME® siding is shown in Figure 18. Additionally, close proximity to a cement producing facility is not recommended as airborne cement is similarly corrosive to galvanized and GALVALUME® Coated Sheet Steels.

Figure 18. Premature corrosion at the bottom edges of the prepainted GALVALUME® panel caused by direct contact with the concrete foundation.

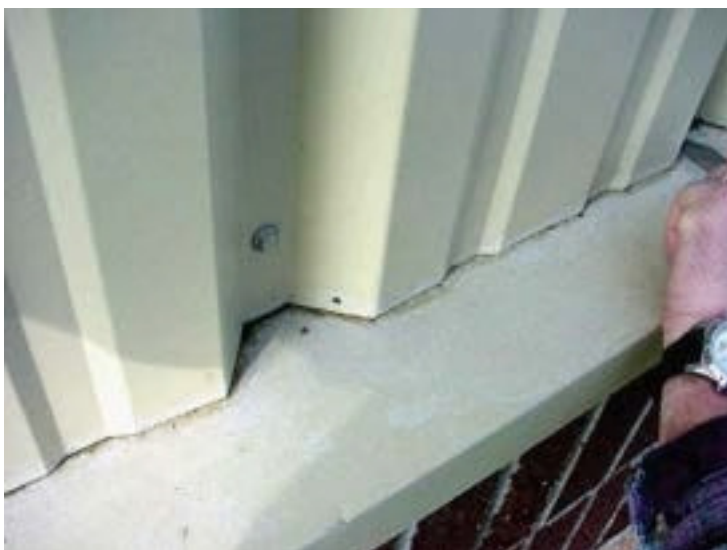
Figure 21 shows premature corrosion on the bottom edge of prepainted GALVALUME® siding where paint blisters and noticeable white residue stain could be observed along the panel edge and on the concrete surface, one year after the installation. This is a typical example of siding installed without flashing on a flat concrete base that does not allow water drainage.

Figure 21. Photograph of premature corrosion on the bottom edge of the siding.

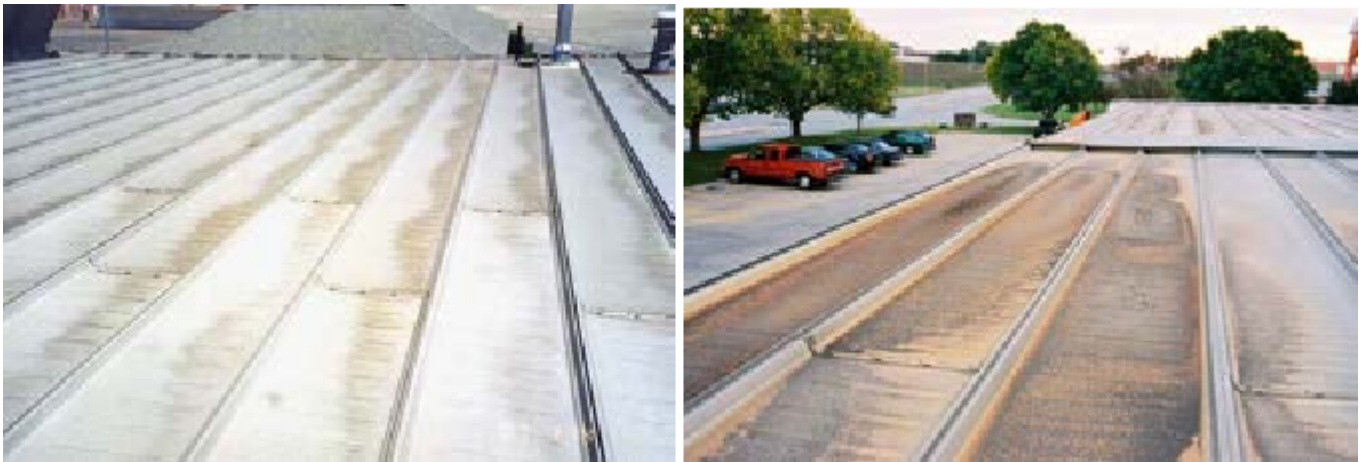
For low slope GALVALUME<sup>®</sup> roof applications, a minimum slope of 1/4:12 is recommended to provide positive water drainage maximizing the GALVALUME<sup>®</sup> roof performance. The examples in Figure 22 show standing seam roofs installed with slopes less than the 1/4:12 minimum, which resulted in water ponding in low areas causing corrosion of the metallic coating.

Figure 22. Photographs of water ponding on a GALVALUME<sup>®</sup> roofs due to improper slope of the roof.

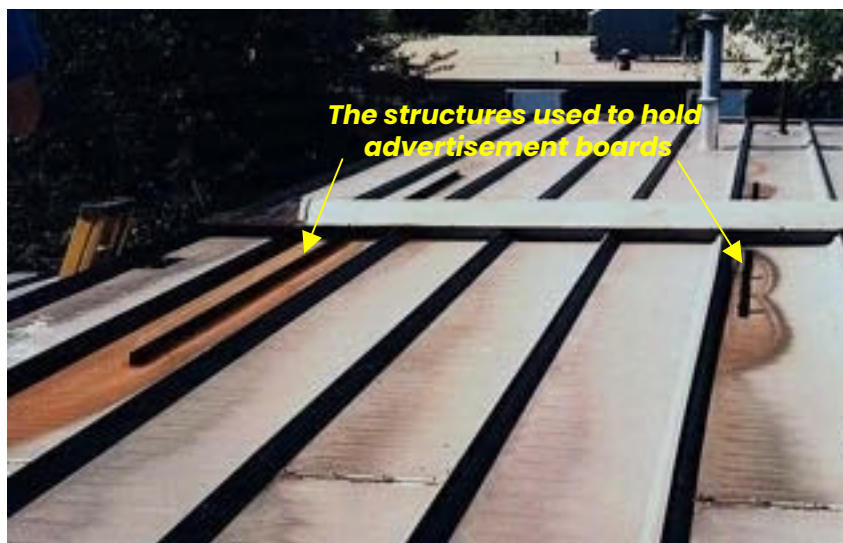
Water ponding may also occur in areas where localized deformation of the roof panels has occurred. The corrosion of the GALVALUME<sup>®</sup> roof panel in Figure 23 was caused by water ponding at the low spots caused by the weight of advertisement boards that had been positioned on top of the roof.

Figure 23. Photograph of a GALVALUME<sup>®</sup> roof after 21 years service. The localized corrosion was caused by water ponding at the low spots where the advertisement boards were set on top of the roof.

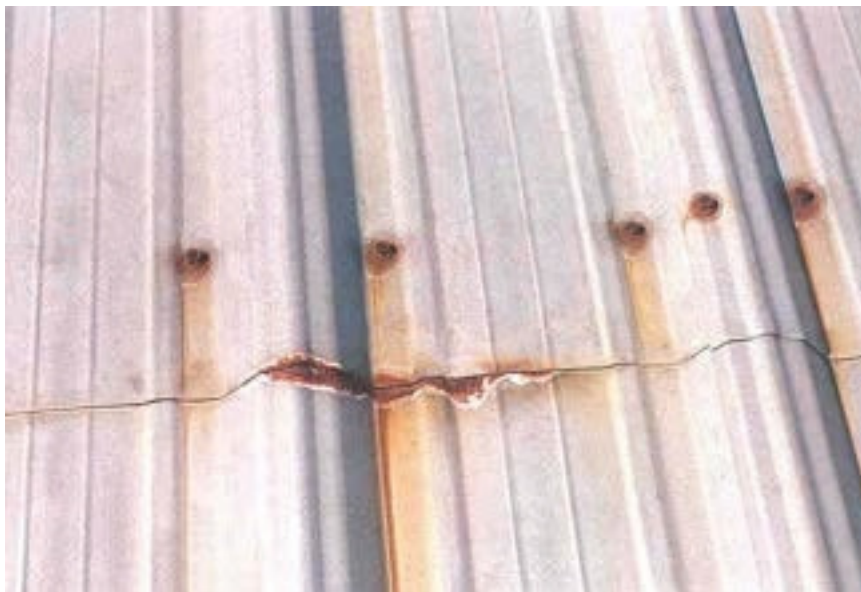
Sealant should be applied at panel end laps to prevent moisture from entering the panel lap joints and causing premature corrosion. Figure 24 <sup>5</sup> shows the crevice corrosion caused by poor end lap sealing on a GALVALUME<sup>®</sup> roof. Figure 25 shows the paint blistering on a prepainted GALVALUME<sup>®</sup> roof caused by poor end lap sealing.

Figure 24. Crevice corrosion caused by poor end lap sealing on a GALVALUME<sup>®</sup> roof.

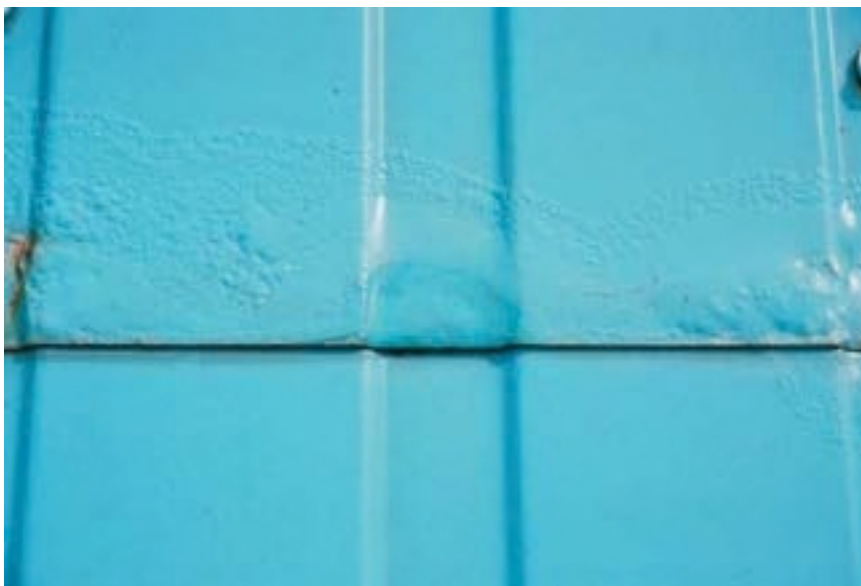
Figure 25. Paint blistering on a prepainted GALVALUME<sup>®</sup> roof caused by poor end lap sealing.

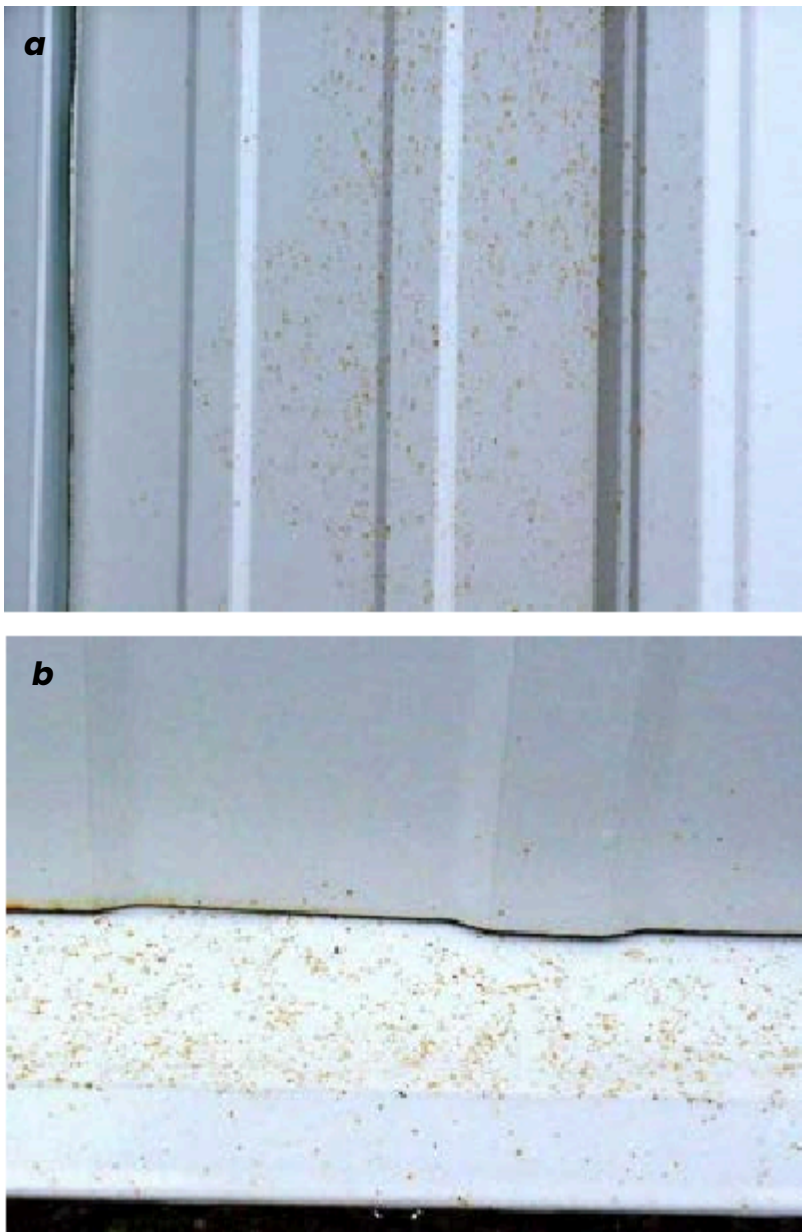
Metal debris from sawing, drilling and other construction processes should be removed during installation. Otherwise, the metal filings will red rust on the surfaces where they were deposited. Red rust of the metal filings may cause stain or discoloration on the surface of the panel whether it is bare or painted and cause appearance issues. Contractors should be cautioned about the importance of removing any debris generated during installation. Cutting and drilling should be done on the backside of the panels in order to avoid damaging the exposed surface with hot metallic particles. Figure 26 shows red rusted metal filings and the stains on a prepainted siding panel and on the concrete base at the bottom of the siding.

Figure 26. Photographs of red rusted metal filings and the stains on a prepainted siding panel (a) and on the concrete base at the bottom of the siding (b).

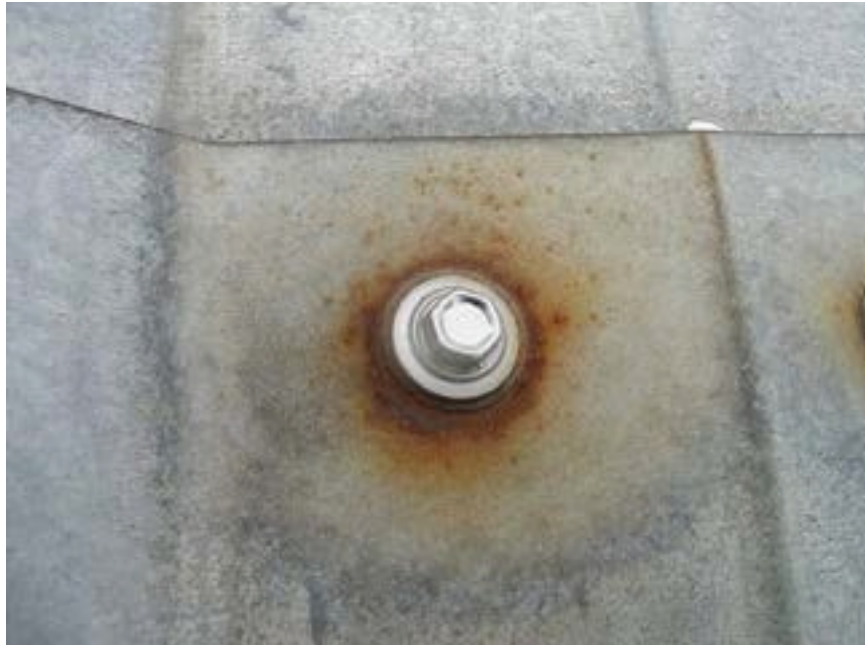
Figure 27 shows the red rusted metal filings on the surface of a bare GALVALUME<sup>®</sup> roof panel around a screw due to failure to remove the metal fines from drilling. Figure 28 shows another example of not removing metal filings after drilling screw holes on a prepainted GALVALUME<sup>®</sup> roof panel. Care must be taken to minimize the contact of hot metal filings from self-drilling or self-tapping screws with the coated panel surface. Any metal filings remaining on the panel surface must be removed at the end of each workday. Otherwise, those fine metal particles will corrode and result in rust staining on the panel surface.

Figure 27. Photograph of red rusted metal filings on the surface of bare GALVALUME<sup>®</sup> roof panel around a screw.

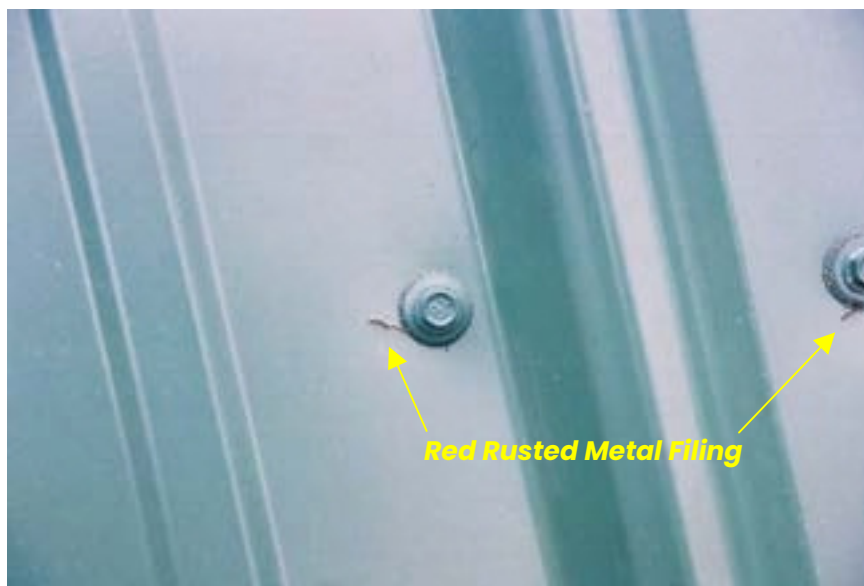
Figure 28. Photograph of red rusted metal filings from the screws on a prepainted GALVALUME<sup>®</sup> roof panel.

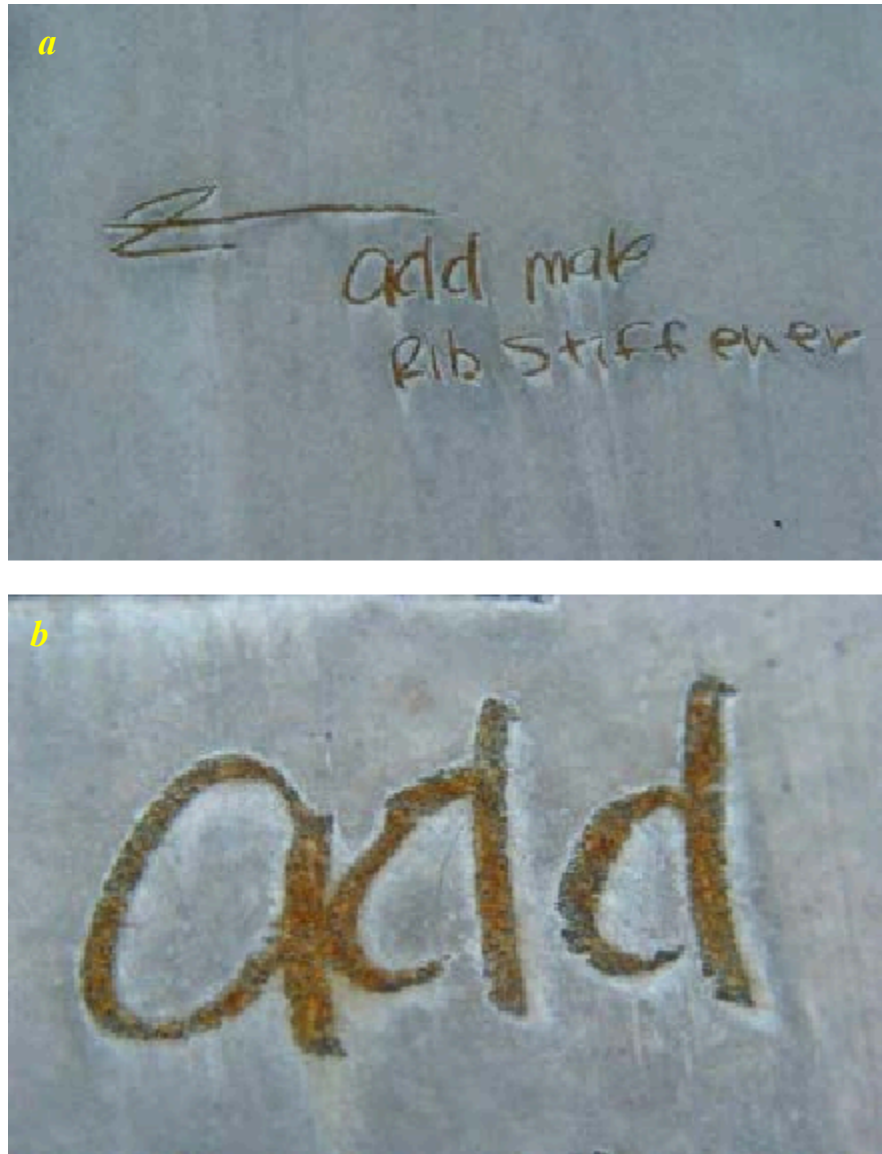
Pencil is made of graphite. When a pencil is used to write on galvanized steel it leaves graphite powder on the surface. Figure 29 is an example of pencil mark corrosion on galvanized steel sheet. Pencil mark corrosion is a form of galvanic corrosion. Because graphite is electrochemically very noble, 3 to 4 volts more noble than the zinc, a strong galvanic cell is created and the zinc on or adjacent to the pencil mark rapidly corrodes. The open circuit potential of graphite is cathodic to all metals and alloys in most aqueous environments. One should never write on galvanized steel with a pencil.

Figure 29. Photographs of pencil mark corrosion on galvanized steel sheet (a), and a magnified view of the mark (b).

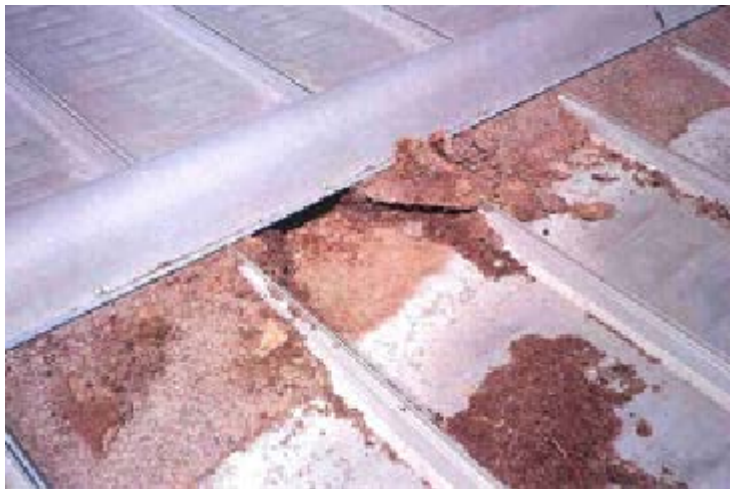
Figure 30. The wood chip debris piled near the ridge cap caused heavy corrosion of the roof panel due to water being retained by the debris.

Debris should be removed from the metal roof during or following installation and through regular roof maintenance because debris can cause staining and premature corrosion. Figure 30<sup>6</sup> shows wood chip debris piled near the ridge cap that caused heavy corrosion of roof panel due to water being retained by the debris. Figure 31<sup>6</sup> shows that the corrosion occurred under the treated lumber because chemicals, particularly copper compounds, leached from the wood accelerating the corrosion. Figure 32 is another example; a piece of metal tube left on the roof caused staining and corrosion of the roof panel.

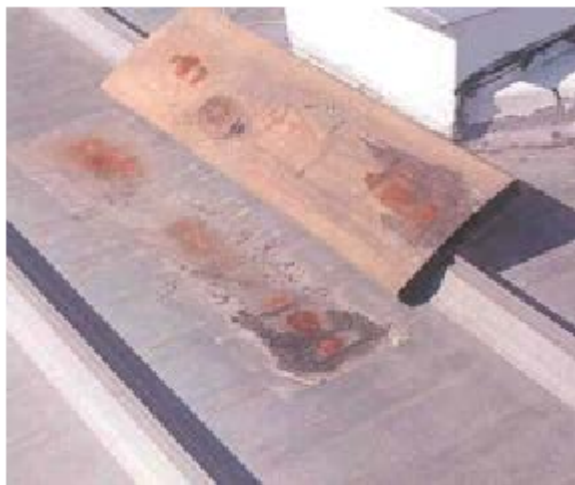
Figure 31. Corrosion occurred under the treated lumber because chemicals, particularly copper compounds, leached from the wood accelerating the corrosion.

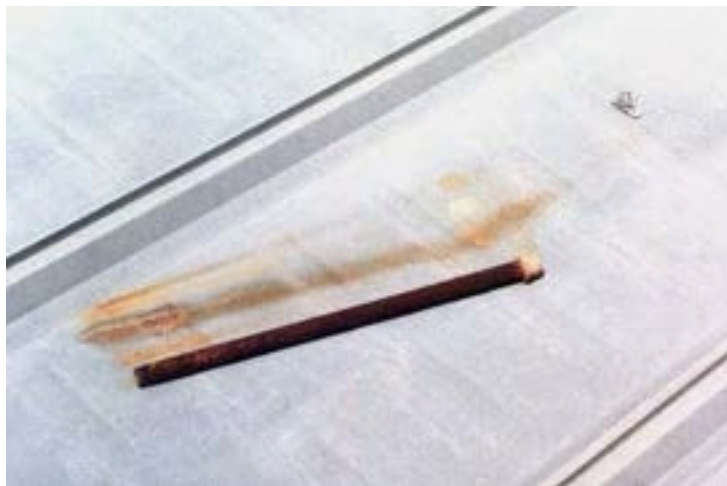
Figure 32. A piece of metal tube left on the roof caused staining and corrosion of the roof panel.

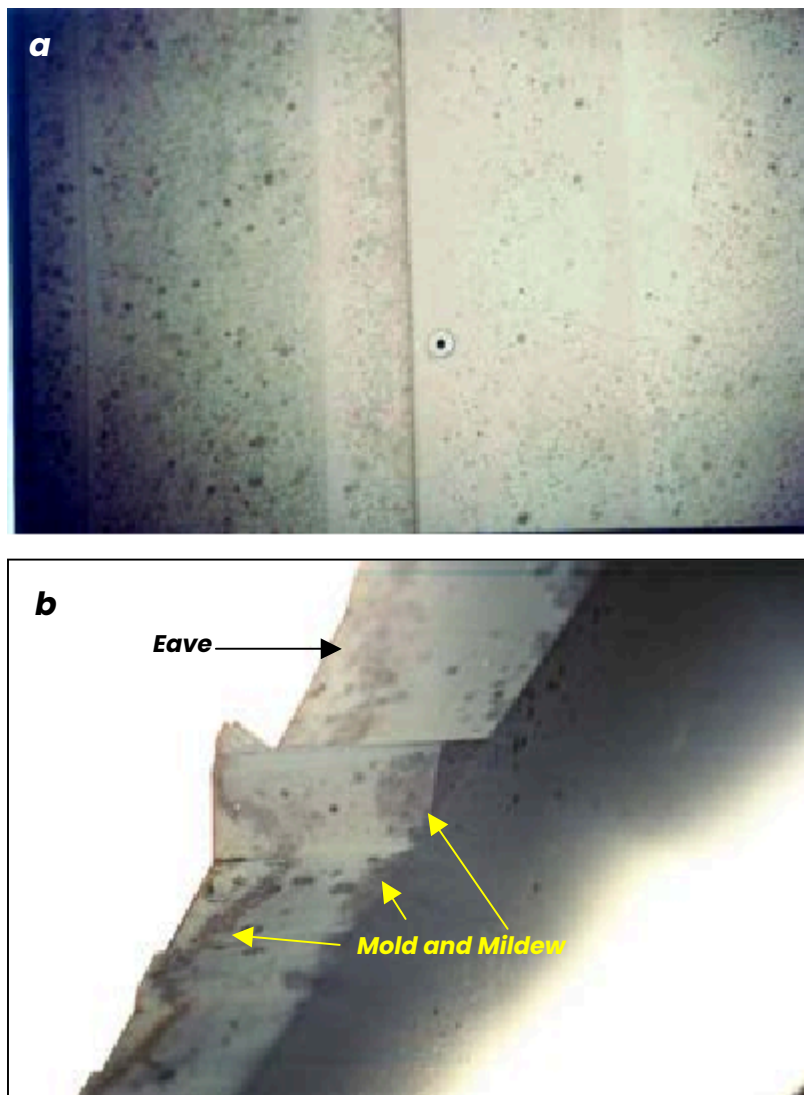
The photographs in Figure 33 show a green/brown appearance of mold or mildew on painted side wall panels and on the under side of the eave, which could cause staining on the surface. This is considered a maintenance issue. Proper ventilation and periodic cleaning should reduce the impact of mold and mildew. Remove mildew by wiping or by using a power spray. Then wash the area with an antiseptic cleaner such as bleach. Rinse the area thoroughly.

Figure 33. Mold or mildew buildup on painted side wall panel (a) and on the under side of the eave (b) where the building was surrounded by a woody area and constantly exposed to a high humidity environment.
