# ***Resolution Manual For Metal Building Construction Job Site Imperfections***

## INTRODUCTION

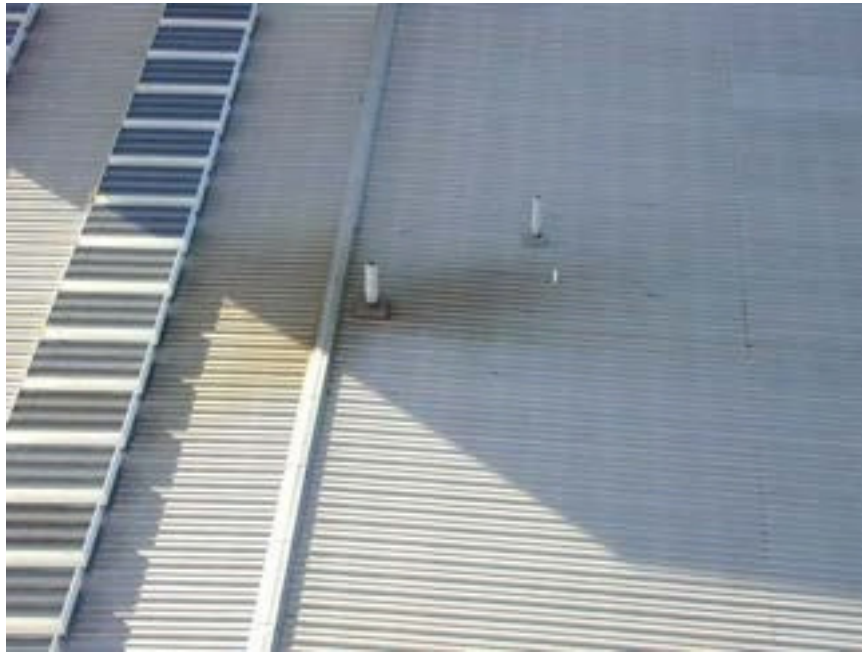
Exhausts discharged through roof stacks can sometimes create corrosive environments around them. The roof panels should be inspected periodically. The panels around exhausts can be coated with recommended maintenance paints, if it is necessary. Figure 34 shows a bare GALVALUME® roof corroded around the vent from a laboratory where acid was constantly used. Figure 35 7 shows that the GALVALUME® roof around the roof stacks was corroded after 20 years due to the exhaust from a space heater.

Figure 34. The bare GALVALUME® roof was corroded around the laboratory vent.

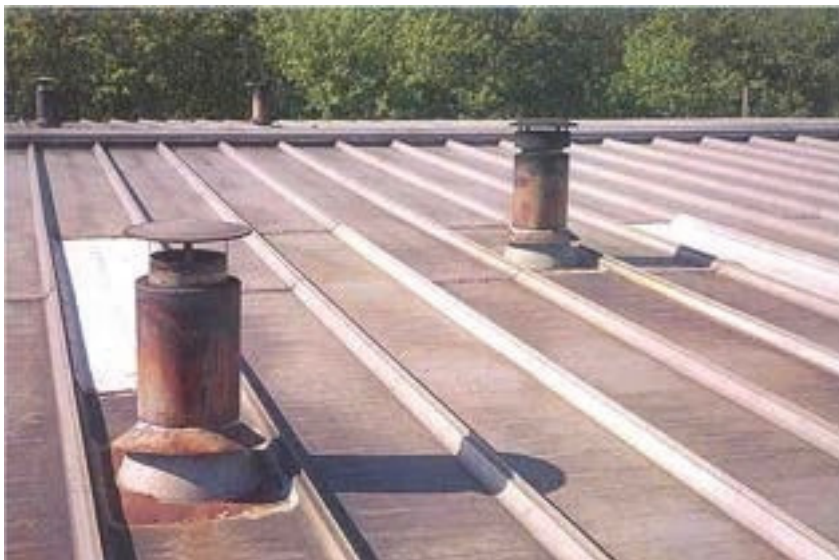
Figure 35. The GALVALUME® roof was corroded around the roof stacks.

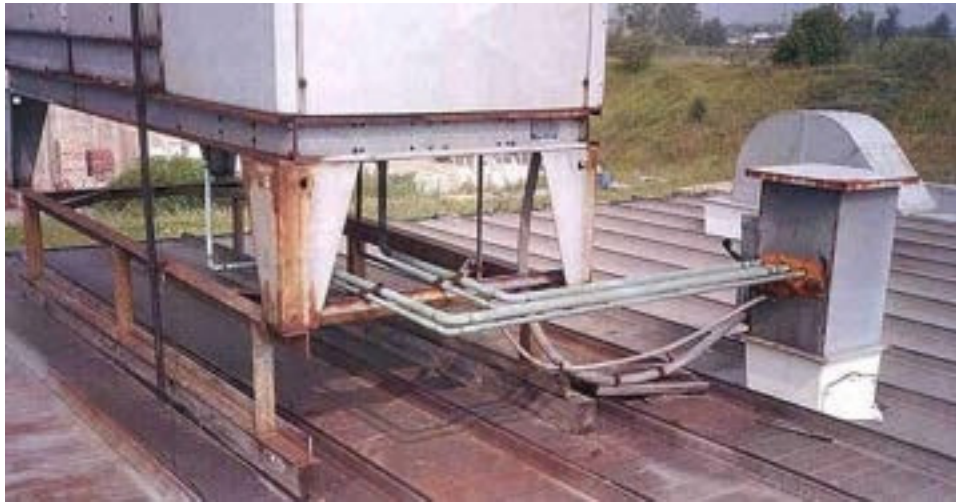
Galvanized and GALVALUME® panels should not be in contact with, or subject to, water runoff from copper, lead, or uncoated steel materials. Condensation water from air conditioning units typically contains dissolved copper, which should be discharged through a plastic pipe extended beyond the edge of the roof. The effect of the condensation water runoff from the copper piping on the GALVALUME® panels is significant in both outdoor and indoor situations, such as shown in Figure 36 8 and in Figure 37.

Figure 36. GALVALUME® roof panel corrosion due to condensation water runoff from the copper pipes.

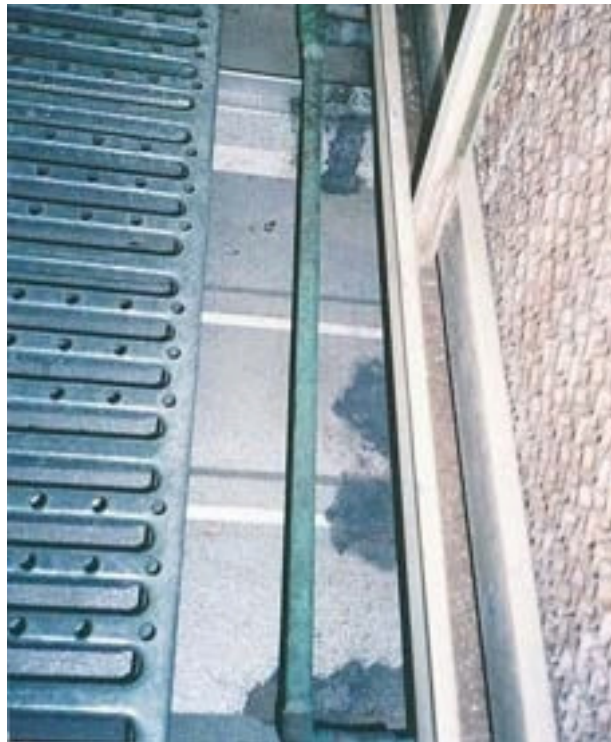
Figure 37. GALVALUME® panel corrosion due to condensation water runoff from the copper pipes.

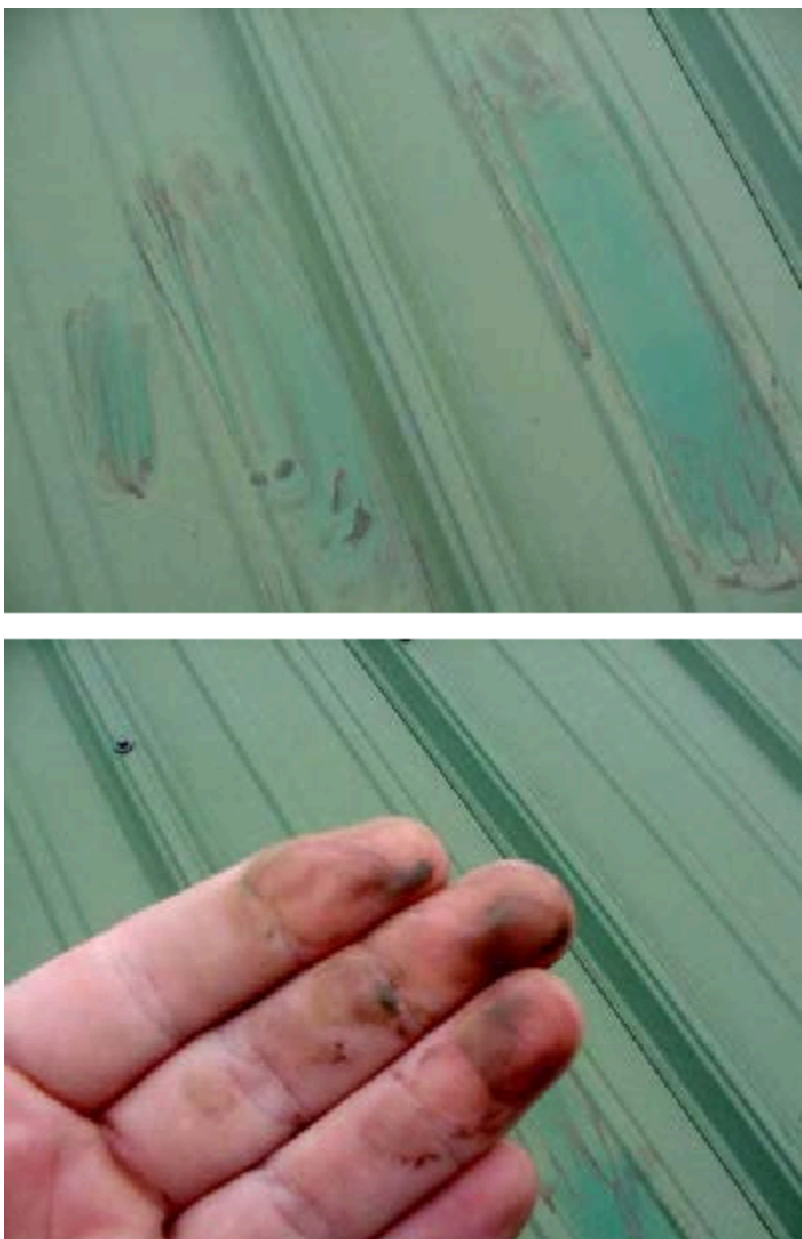
Two types of dirt accumulate on buildings: dry soil and greasy or organic residues. The dry dirt, by itself, washes off with rain or high-pressure water spray. Greasy residues do not wash off in rain and hold dry soil and chalk tightly to the surface. These residues originate from automobile exhaust, fireplaces, ventilation fan oil, pesticides, and various other common sources. This is the kind of dirt that requires cleaners for removal. Detergents, ammoniated cleaners and solvents are particularly effective in removing this greasy kind of dirt. Generally, lighter colors show dirt more than dark colors. However, dirt remaining on a darker roof can also cause discoloration, an example of which is shown in Figure 38. The bright color has been covered by dirt.

Figure 38. The prepainted GALVALUME<sup>®</sup> roof panel discoloration is due to dirt coverage.

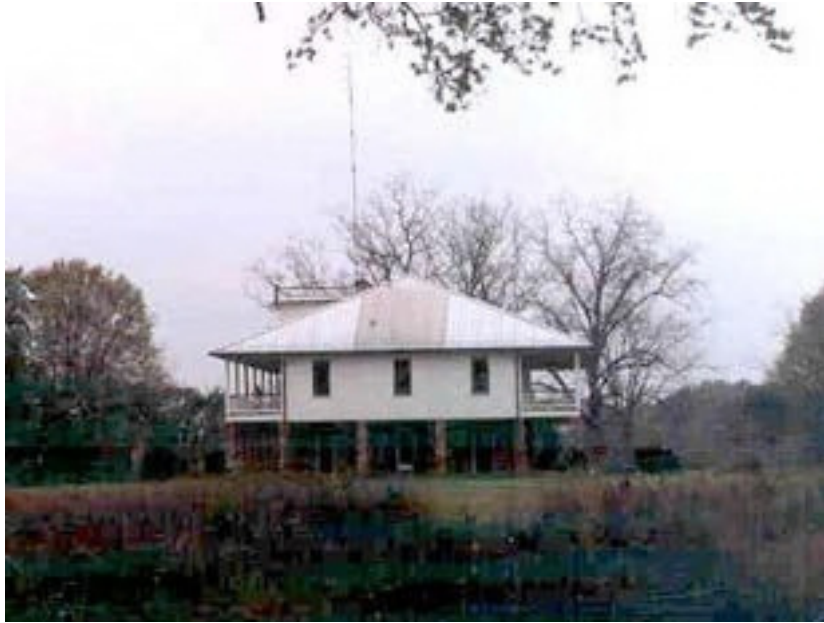
Bare GALVALUME<sup>®</sup> Coated Sheet Steel is not recommended for high visibility applications, such as the high slope roofing application shown in Figure 39, because of the potential for differential darkening. The darkening variation can be minimized by supplying material from one supplier and from one master coil. Consecutive master coils supplied by the steel mill will also reduce, but not eliminate the possibility of variation. The darkening variation may also be observed on ACRYLUME<sup>®</sup> Coated Sheet Steel panels (Figure 40). Therefore, if the application requires a consistent surface appearance, a painted product is recommended.

Figure 39. Differential darkening of bare GALVALUME<sup>®</sup> panels on a high slope roofing application.

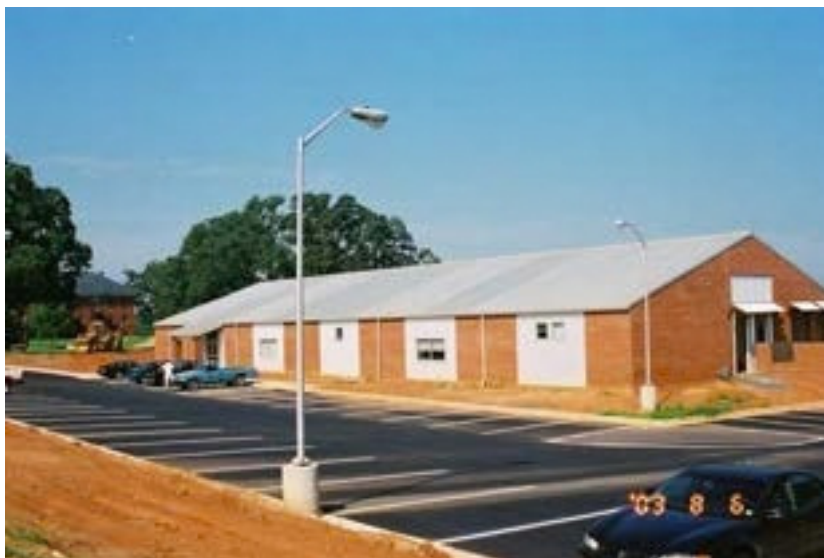
Figure 40. Differential darkening of ACRYLUME<sup>®</sup> panels on a high-slope roofing application.

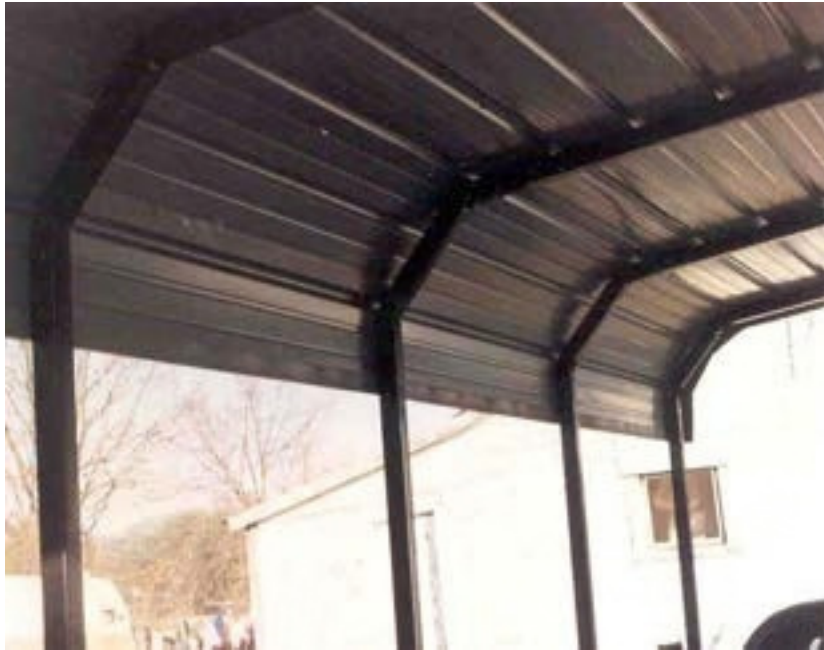
The design of metal roofing should allow water runoff and also provide adequate ventilation to prevent condensation. An improper design will affect the corrosion performance of the roofing panels whether they are bare or painted. The roof design shown in Figure 41 does not allow rainwater to runoff along the curvature of the roof, causing condensation to accumulate on the backside of the panel along the ribs (Figure 42). Contractors should be warned of the potential impact of such applications and designs, which do not allow effective water runoff or proper ventilation.

Figure 41. Improper roof profile design of a pole building with open sides does not allow rainwater to runoff along the curvature of the roof.

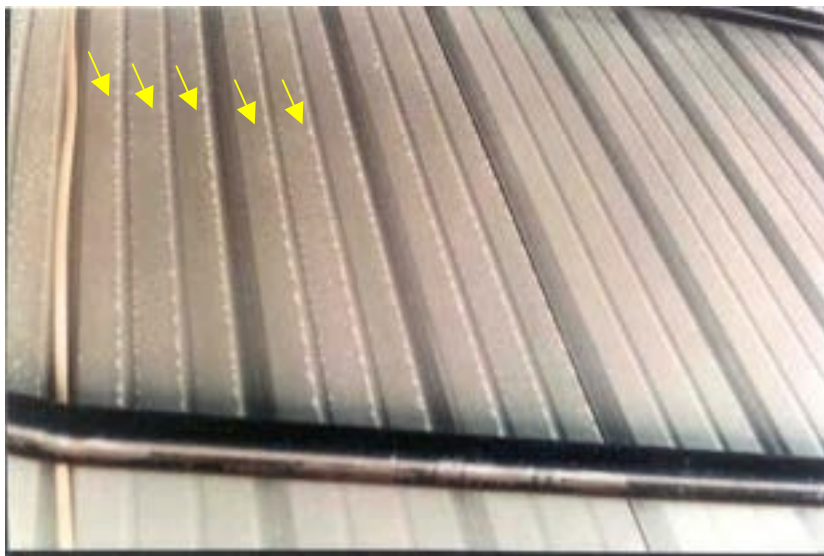
Figure 42. Photograph of the backside of the roofing panel shows condensation accumulating along the ribs of the panel as the arrows indicate.

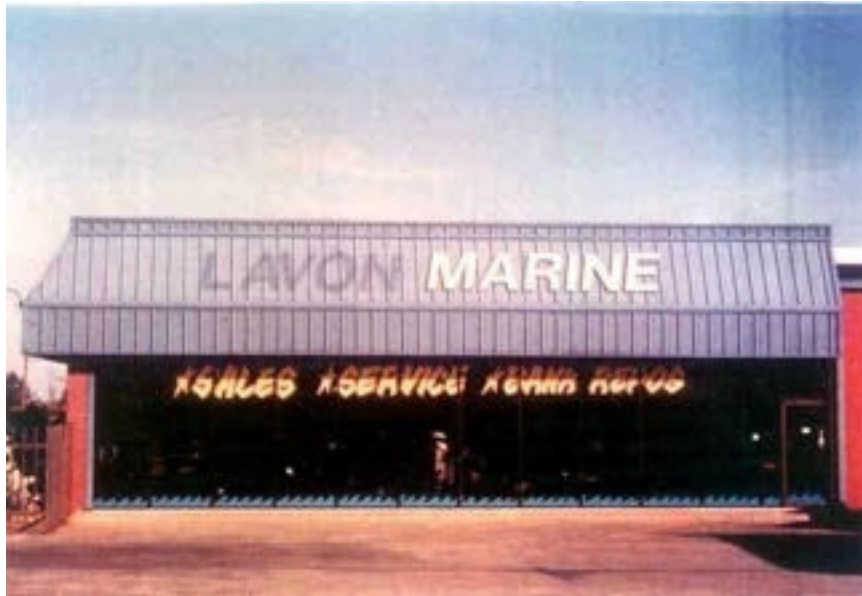
Fading is typically caused by the breakdown of the components of the paint film by UV light from the sun. Paint suppliers indicate the degree of fading that can normally be expected from a particular paint system over a given time period. An area that is blocked from the UV exposure will have less fading than areas exposed to the sun. An example of this is shown on the building in Figure 43. In the case of non-uniform fading of the paint, such as the pre-painted roof in Figure 44, there are noticeable differences in color between one section and another section of the roof panels. The amount of fade should be evaluated by the representatives of the coil coater or paint supplier to determine the cause.

Figure 43. Color fading of the paint on pre-painted panels due to UV light from the sun.

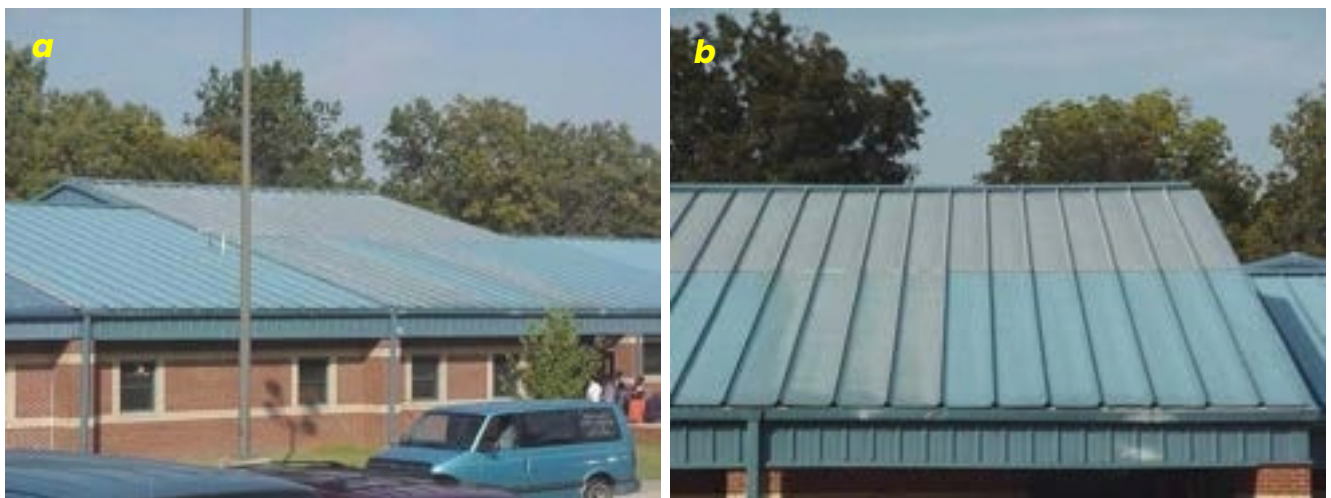
Figure 44. Non-uniform fading of a pre-painted roof with noticeable differences in color from one section to another section (a) and its close look (b).

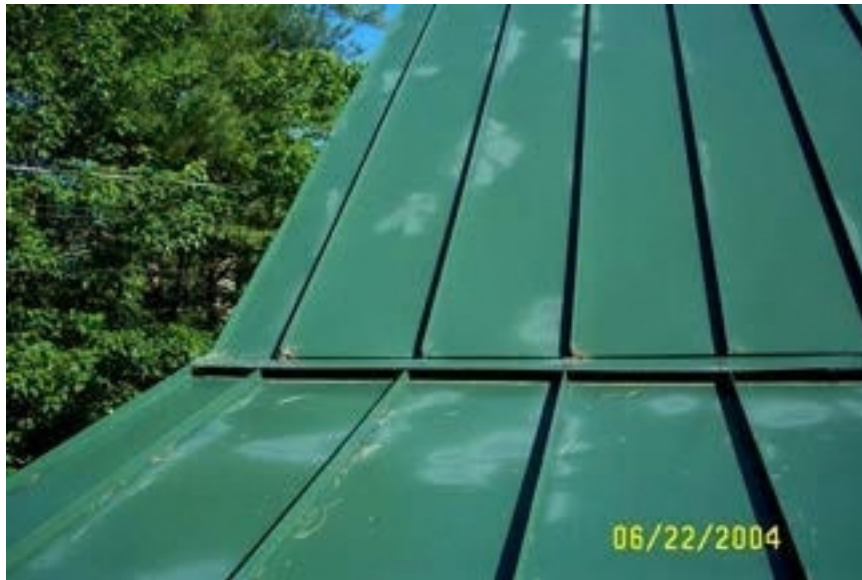
Touch-up paint is often used to repair or cover the scratches, abrasion marks or other lightly damaged areas on prepainted building panels. Appropriate touch-up paints, normally supplied by the paint manufacturers, will match the colors and meet the performance requirements with the paint on the building panels. If unsuitable touch-up paint is used, it may cause differential chalking and fading appearance on the painted panel, which may require repainting of the entire affected surface. The pictures below demonstrate the poor performance of improper touch-up repair paints, which have caused differential chalking and fading appearance on the prepainted GALVALUME® steel roof (Figure 45) and on the prepainted hot-dip galvanized steel siding (Figure 46).

Figure 45. Differential chalking and fading appearance on the prepainted GALVALUME® steel roof with improper touch-up paint.

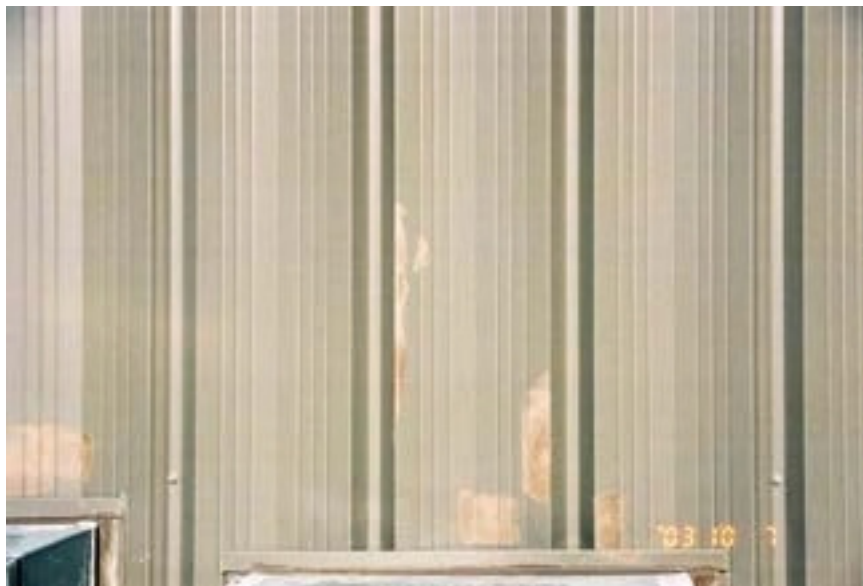
Figure 46. Differential chalking and fading appearance on prepainted hot-dip galvanized steel siding with improper touch-up paint.

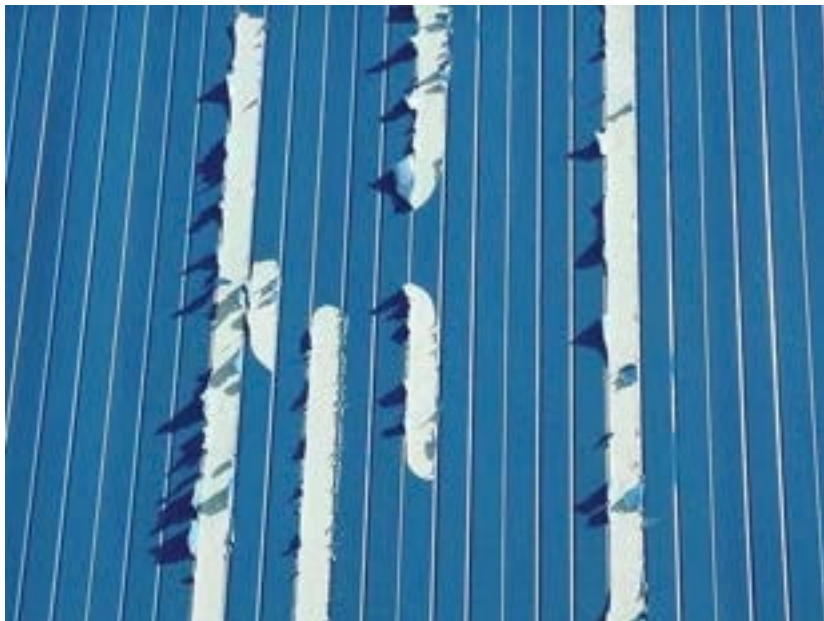
Generally, paint systems for exterior building panel applications consist of a primer and a topcoat. The primer should provide good adhesion to the coated steel substrate and to the topcoat. Figures 47 to 49 show an example of inter-coat adhesion failure of the paint where the topcoat has delaminated from the primer on the prepainted GALVALUME<sup>®</sup> Coated Sheet Steel. The primer still remains on the surface of the coated steel sheet substrate (Figure 49). In this case, the failure is not related to the GALVALUME<sup>®</sup> Coated Sheet Steel. The coil coater and paint supplier should be contacted to resolve this issue.

Figure 47. Inter-coat adhesion failure on a prepainted GALVALUME<sup>®</sup> panel.

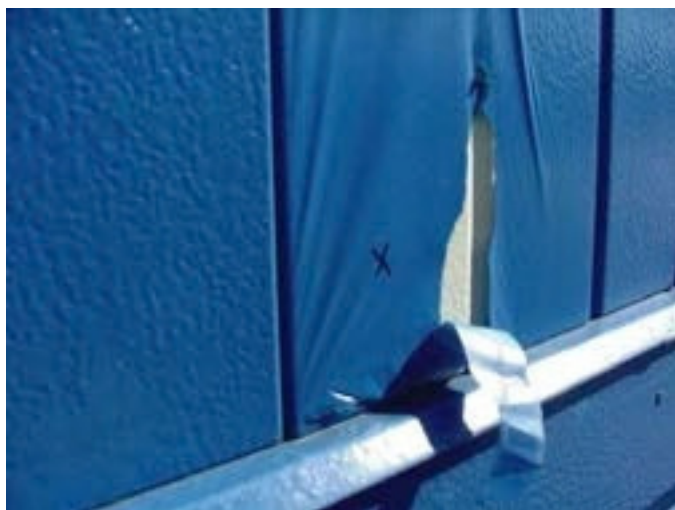
Figure 48. The topcoat delaminated from the primer.

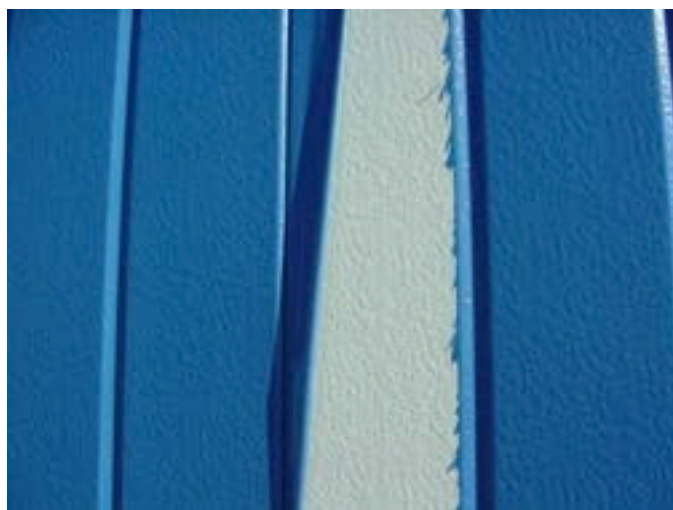
Figure 49. The primer remained on the panel where the topcoat peeled off.
